HANCOCK TOWN OFFICE- PARKING LOT & SITE ACCESSIBILITY UPGRADES

1027 VT ROUTE 100, HANCOCK, VT 05748

The town of Hancock Vermont has been working with Vermont Integrated Architecture, P.C. (VIA) to develop plans for the renovation of various site elements at their town office building, located at 1027 VT Route 100 in Hancock, Vermont.

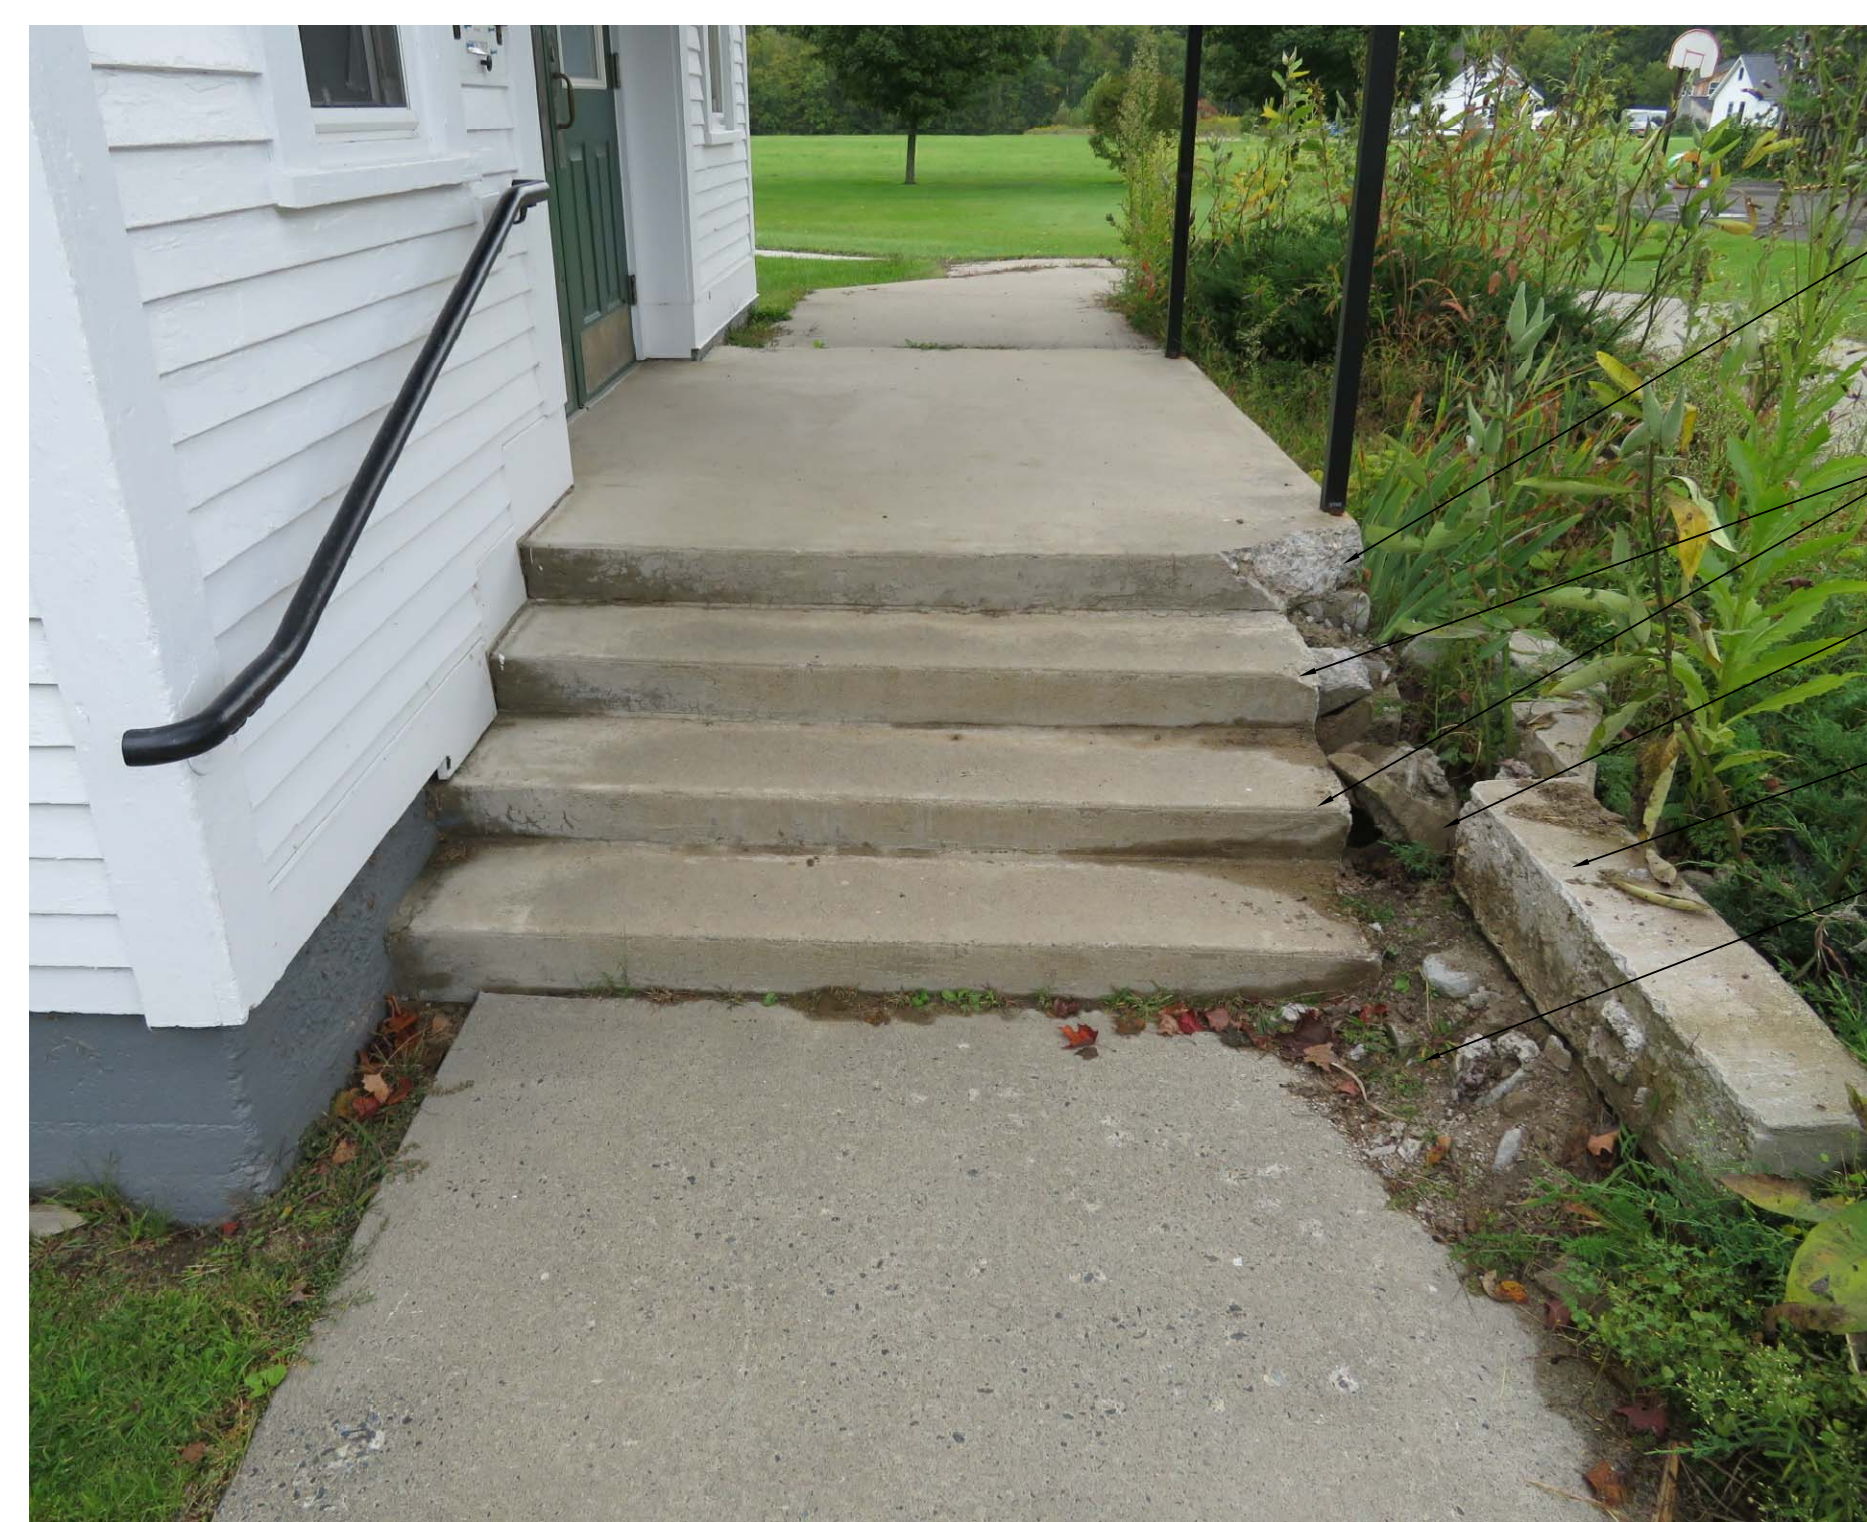
2 Existing Stair Condition Photo
 SCALE: Not to Scale

- REPAIR DAMAGED CORNER OF EXISTING CONCRETE LANDING
- REPAIR DAMAGED CORNER OF EXISTING CONCRETE STEPS
- REMOVE EXISTING CONCRETE STRINGER UNIT AND ASSOCIATED CMU'S. INFILL GRADE.
- REMOVE CONCRETE MEMBER
- REMOVE DEBRIS. REPAIR CONCRETE BELOW AS NECESSARY
